**COLONY AND PROTECTORATE OF KENYA**

**COMMISSION OF INQUIRY INTO THE  
PARTIAL FAILURE OF THE NGONG  
ROAD WEST OF DAGORETTI  
CORNER**

1952

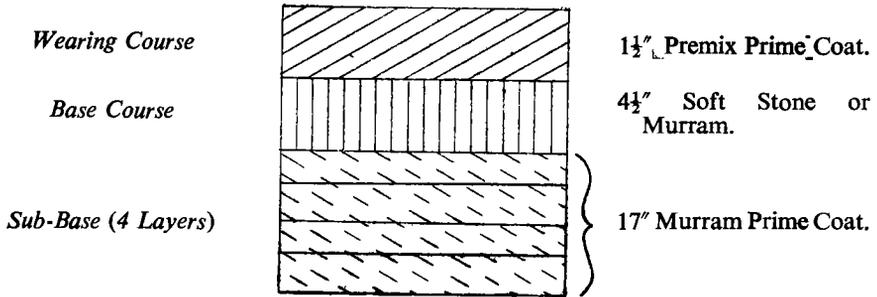
CONSULTANTS' SPECIFICATION—(10,000 lb. WHEEL LOAD)

3. The Consultants' opinion and specification were on the basis of a 24-foot bituminized carriageway capable of carrying a 10,000 lb. wheel load. They estimated that a total pavement thickness of 13 inches was required over a red clay sub-grade, and 23 inches over a black-cotton soil sub-grade; and they recommended a 4½-inch base of crushed rock, properly compacted, over a sub-base of selected murrum, and covered by a dense pre-mix bituminized surfacing 1½ inches thick. They further reported that the existing pavement thickness of the old road was 6½ inches where it had a bituminized surface, and 7 inches over the rest of the road.

TOTAL 23"

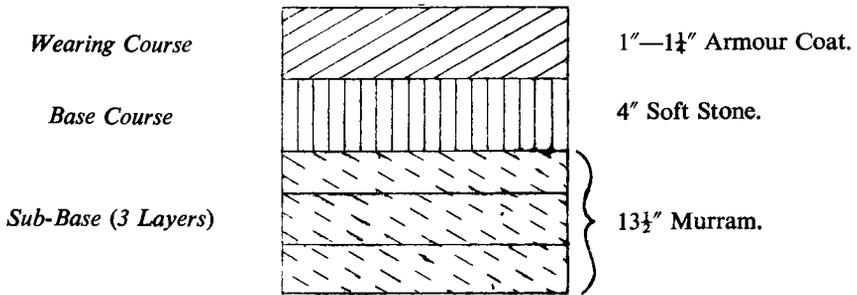
COUNCIL'S SPECIFICATION AMENDED BY P.W.D.—(7,000 lb. WHEEL LOAD)

6. The amendments resulted in a specification on red soil of 9 inches of murrum sub-base, 4 inches of water-bound macadam stone base-course, and 1 inch of wearing surface, giving a total pavement thickness of 14 inches over red soil. The specification on black-cotton soil was 13½ inches of murrum sub-base, 4 inches of waterbound macadam stone base-course, and 1 inch of wearing surface, giving a total pavement thickness of 18½ inches over black-cotton soil.

TOTAL 18½"

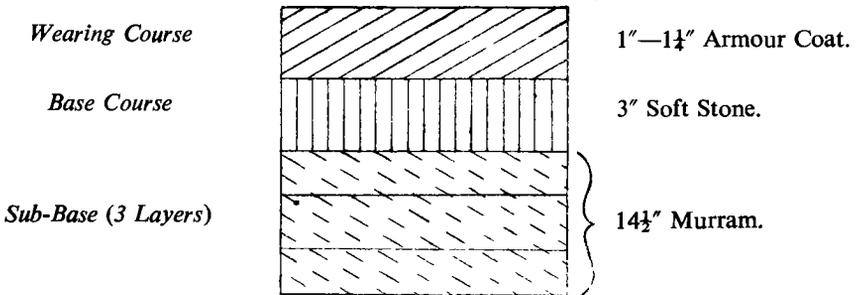
TOTAL 18½"—FIRST AMENDMENT

8. The Council's Engineer was doubtful of the ability of his staff and plant to make a good job of water-bound macadam, using soft stone; but eventually he agreed to undertake it, provided that help in the form of technical advice was given by the Public Works Department, and that, on grounds of cost, the base-course was 3 inches thick instead of 4 inches, the difference of 1 inch being made good in the murrum sub-base. This was approved, and the working specification of the road became 1 inch of armour coat wearing surface, over 3 inches of waterbound soft stone macadamized base-course over, in the case of red soil, 10 inches of murrum sub-base and, in the case of black-cotton soil, 14 $\frac{1}{2}$  inches of murrum sub-base.

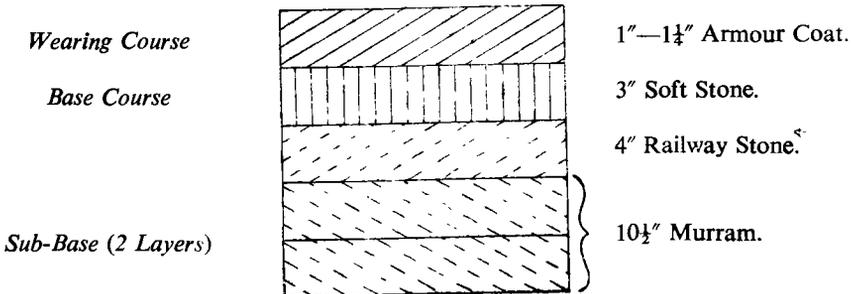
TOTAL 18½"—SECOND AMENDMENT

9. The work was put in hand in November, 1949, on this specification; but, as it progressed, the quality of the murrum in the sub-base deteriorated to such an extent that it became no longer suitable, and the specification for the construction of approximately the last 1 $\frac{1}{2}$  miles of the road to Dagoretii Corner was amended to provide that the top 4 inches of the sub-base should be 4 inches of crushed stone from the Railway quarry instead of murrum.

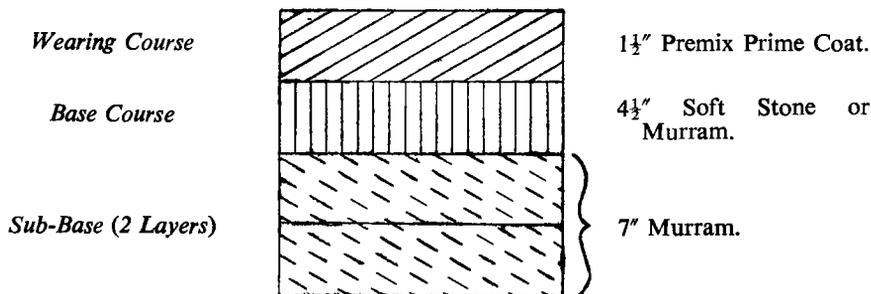
CONSULTANTS' SPECIFICATION—(10,000 lb. WHEEL LOAD)

TOTAL 13"

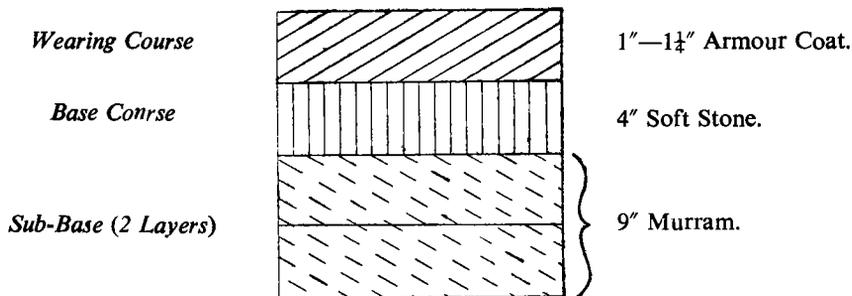
COUNCIL'S SPECIFICATION AMENDED BY P.W.D.—(7,000 lb. WHEEL LOAD)

TOTAL 14"
